# Verify before backfill.

Below-grade wall assembly | Follow-up required

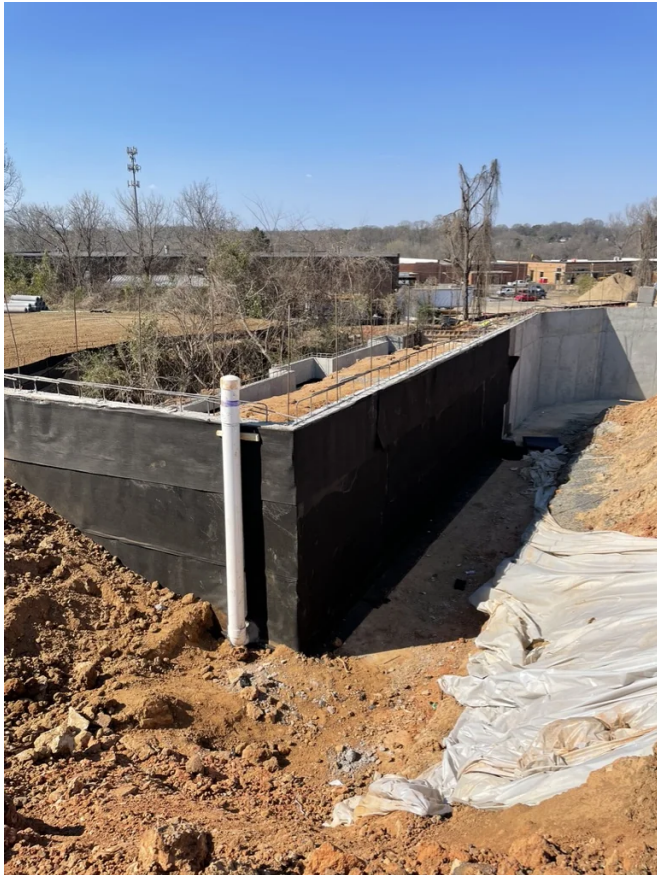
Original field photograph. Visible conditions only.

Black surface material covers the visible concrete wall faces. The adjacent excavation remains open.

The open excavation provides a chance to document the assembly before backfill conceals it.

The photograph does not identify the product or thickness, confirm wall-base drainage or establish the white pipe's purpose.

Completion evidence requested. Confirm the relevant assembly and records before accepting this scope as complete.

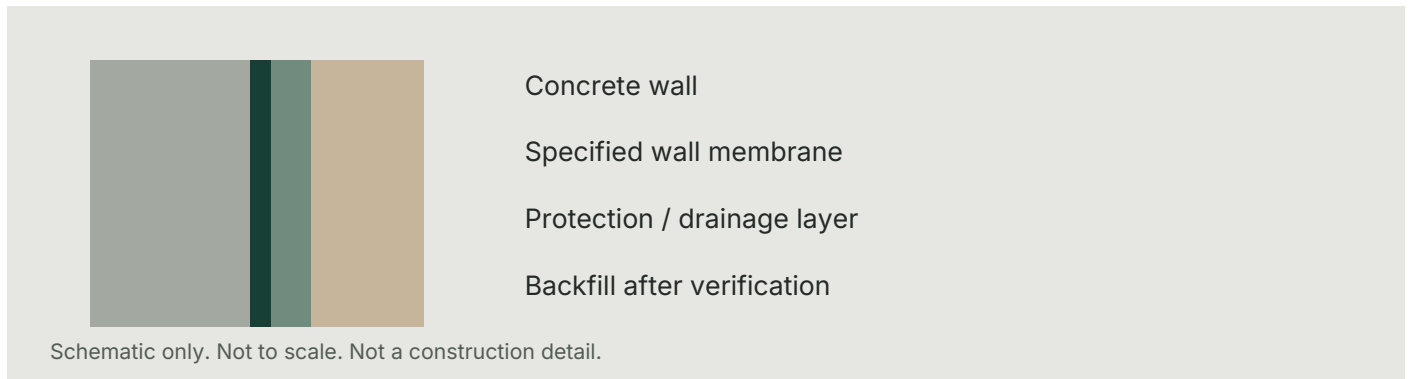
Illustrative drawing detail W-01

A coated wall does not substantiate every component in the example detail. Request the approved wall detail, product submittal and installation instructions. Match the visible stage to records of the work before concealment.
